# Stockton Junction

## Study Report

Project Title: Stockton Parish Council

Document No: P0103-1099-01

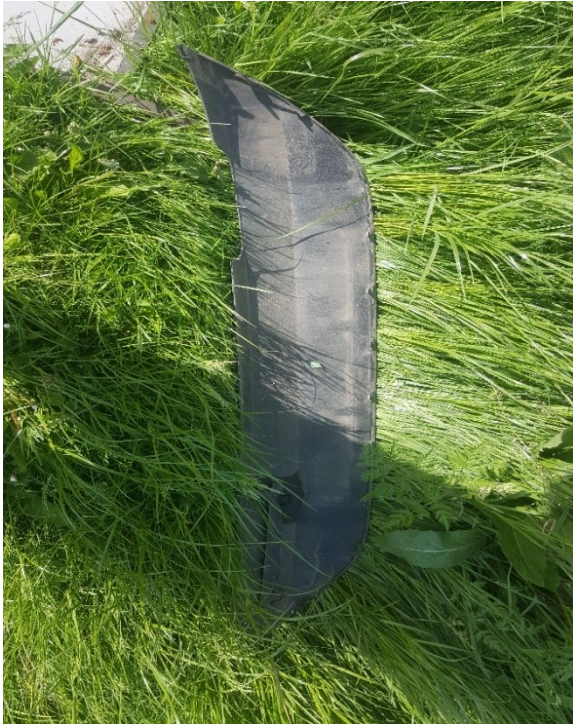
It is the position of the Parish Council that more accidents are occurring at this junction than are being reported in the STATS19 data. Assuming that there is no under-reporting of accidents that result in injury, then it would seem that damage-only accidents, which tend not to result in Police attendance, are occurring with sufficient frequency to alarm residents. This is supported by the prevalence of vehicle debris on site; a bumper, coloured light plastics, a rear-view mirror. See Figure 4, Figure 5, Figure 6 and Figure 7.

**Figure 4 - bumper section on verge**

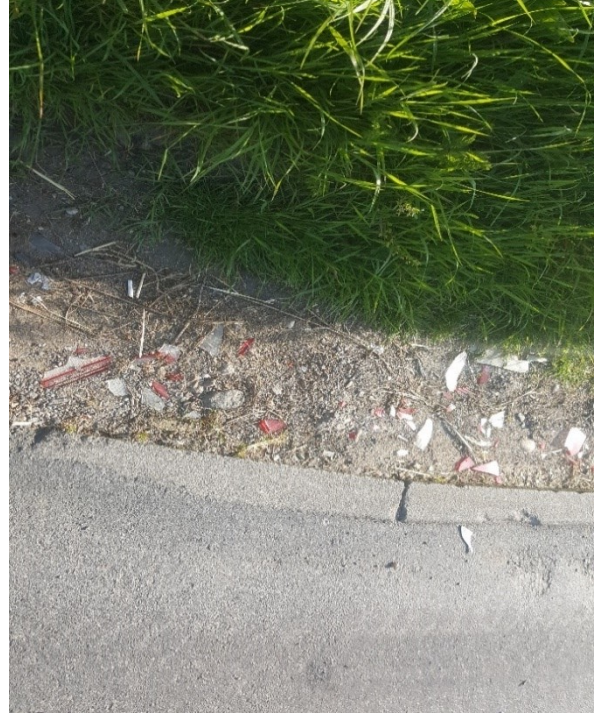
**Figure 5 - broken light lens debris**

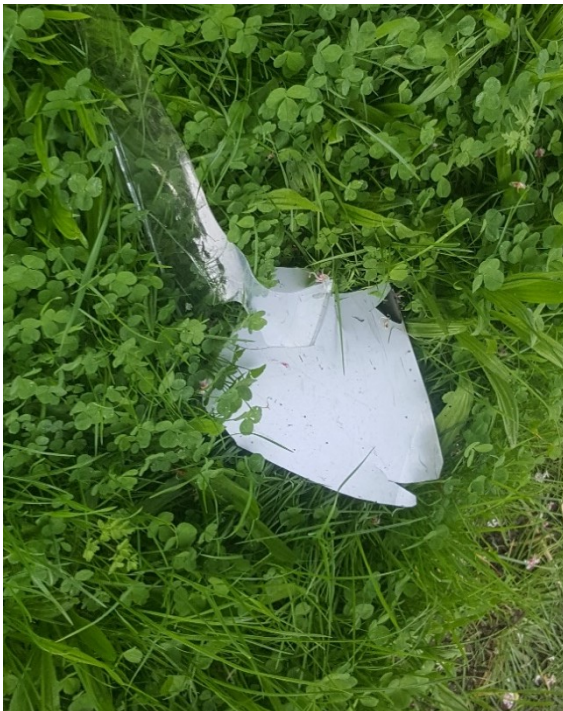
**Figure 6 - car bumper debris**

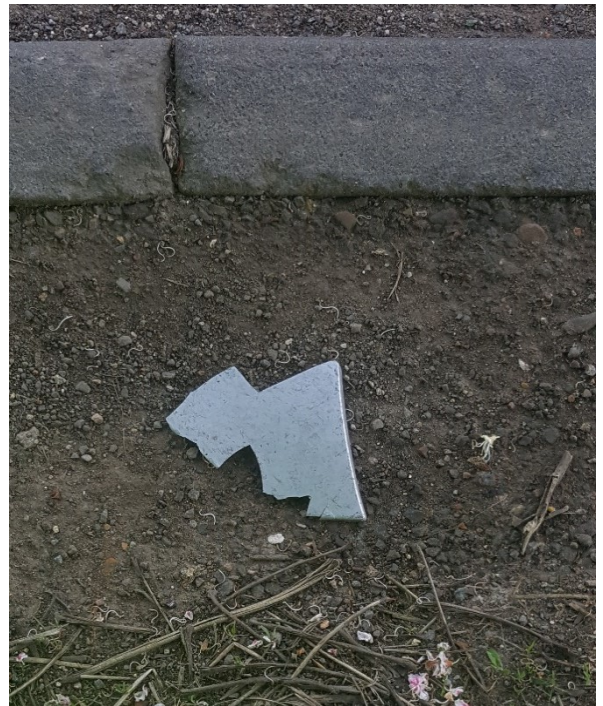
**Figure 7 - more car bumper debris**

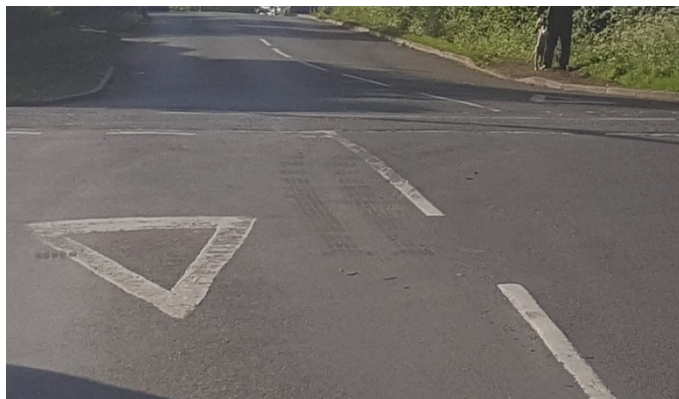
There is evidence of scoring of the road surface and tyre marks at the junction that suggests drivers are performing abrupt right turn manoeuvres from both Stockton Road and Napton Road. This was apparent during the site survey with several vehicles observed wheel-spinning.

Figure 8 - wheelspin marks Stockton Road approach

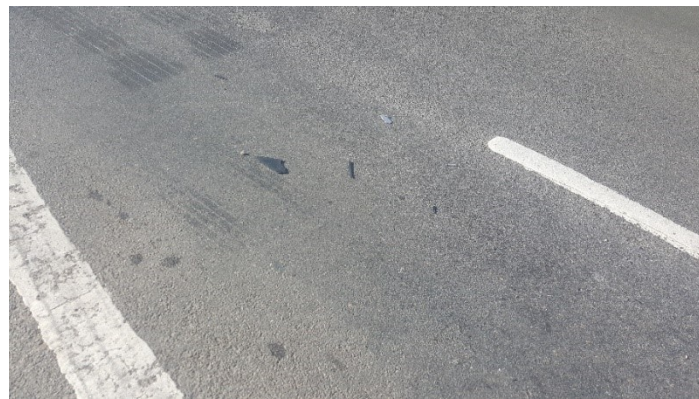
Figure 9 - multiple spin marks

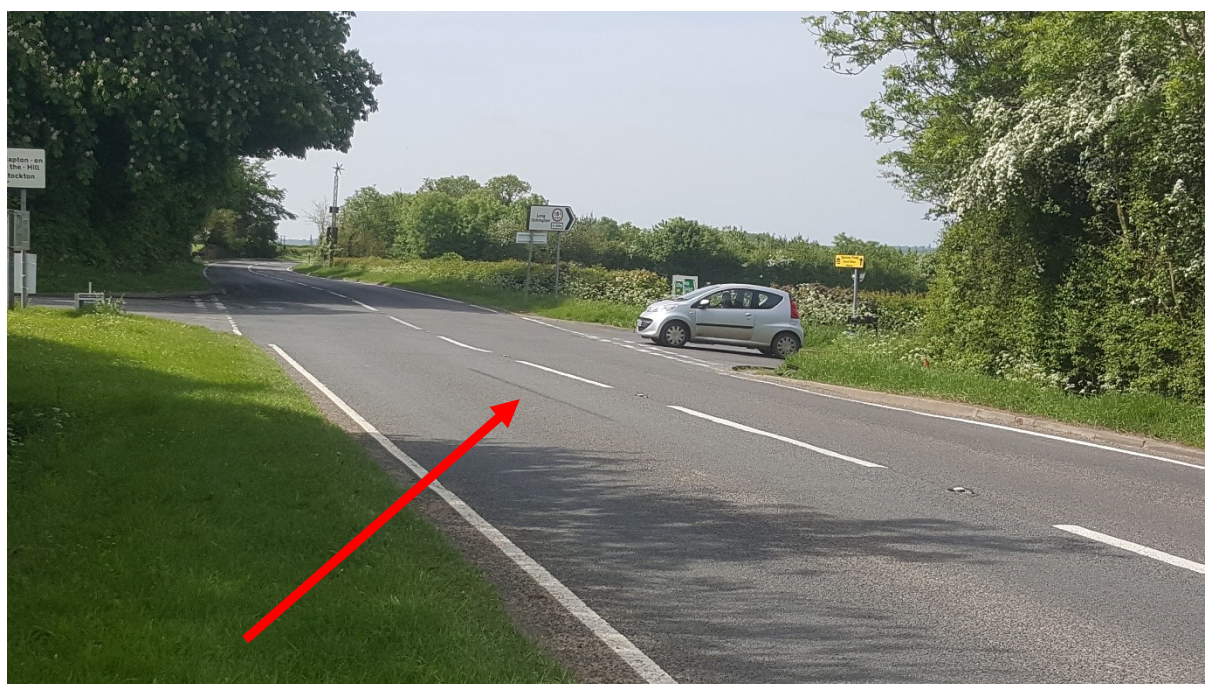
Figure 10 - skid mark on A426; evidence of a near miss or a damage only collision

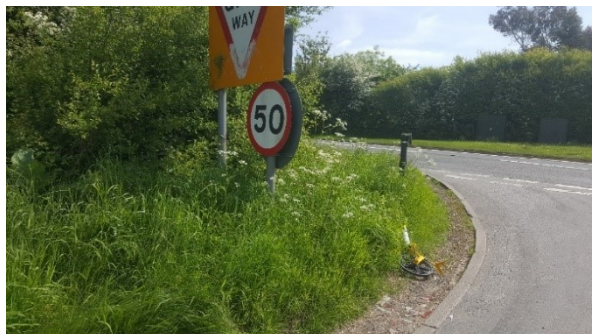
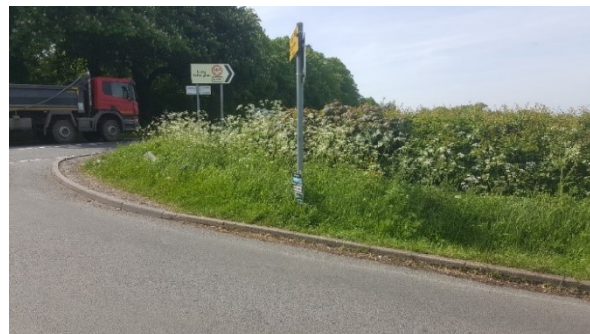
**Figure 11- visibility to the left at 9m back from channel line**

**Figure 12 - visibility to the right at 9m back from channel line**

Figure 11 and Figure 12 show the visibility distance is not achieved at the 9m 'X' distance. The standard then relaxes the 'X' distance of 9m to 4.5 in 'difficult circumstances' for lightly trafficked junctions but does not define what constitutes light traffic. Certainly, recent housing development on both sides of the junction will have increased traffic and not all units are occupied yet, so traffic levels will undoubtedly increase further, thereby strengthening the case for an improvement in current visibility. Traffic flows could certainly be considered more than 'light' for the short peak periods.

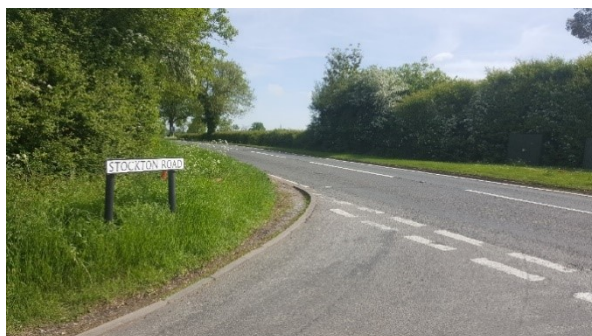
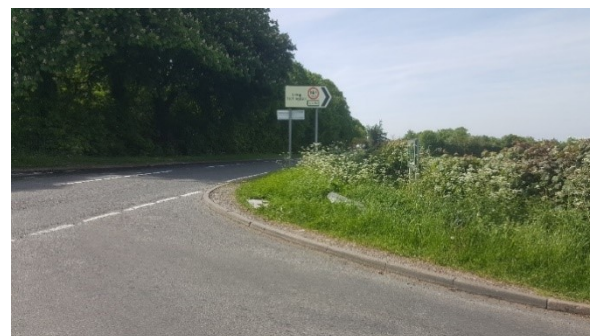
**Figure 13 – visibility to the left at 4.5m back from channel line**

**Figure 14 – visibility to the right at 4.5m back from channel line**

In any case Figure 13 and Figure 14 show the visibility distance is also not achieved at the 'relaxed' 4.5m 'X' distance.

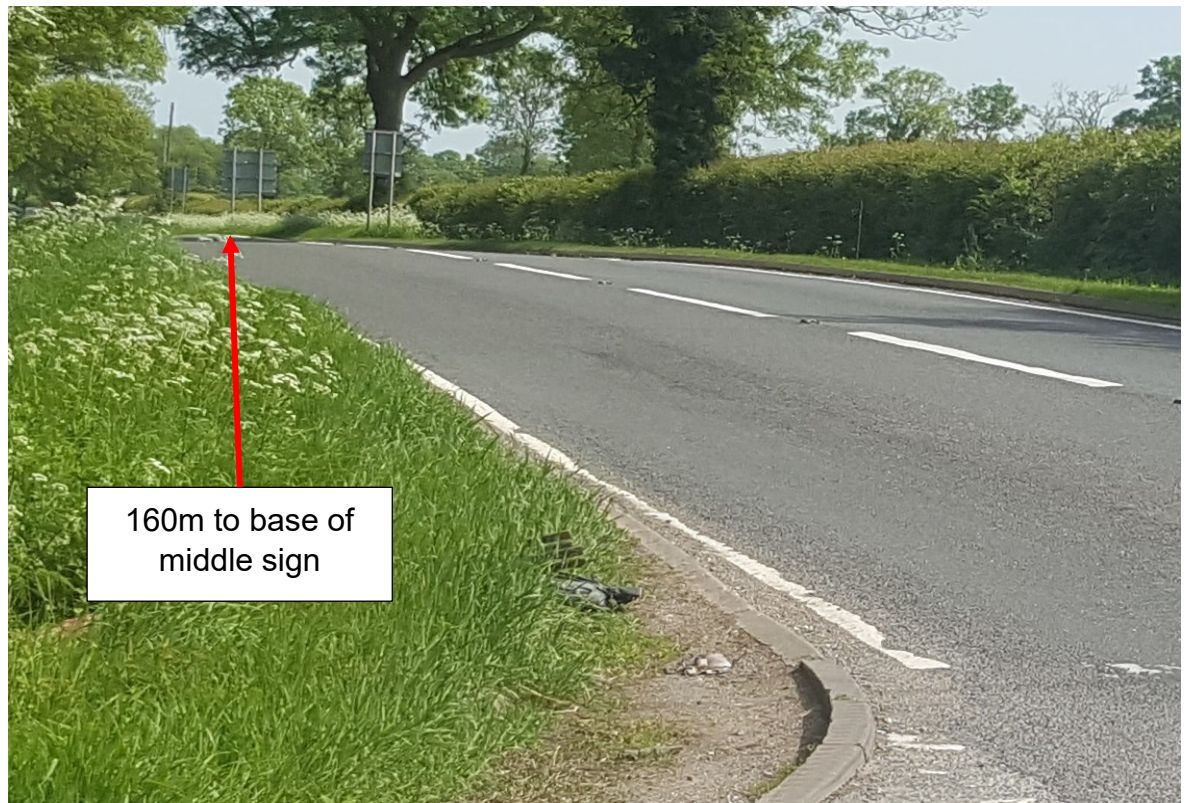
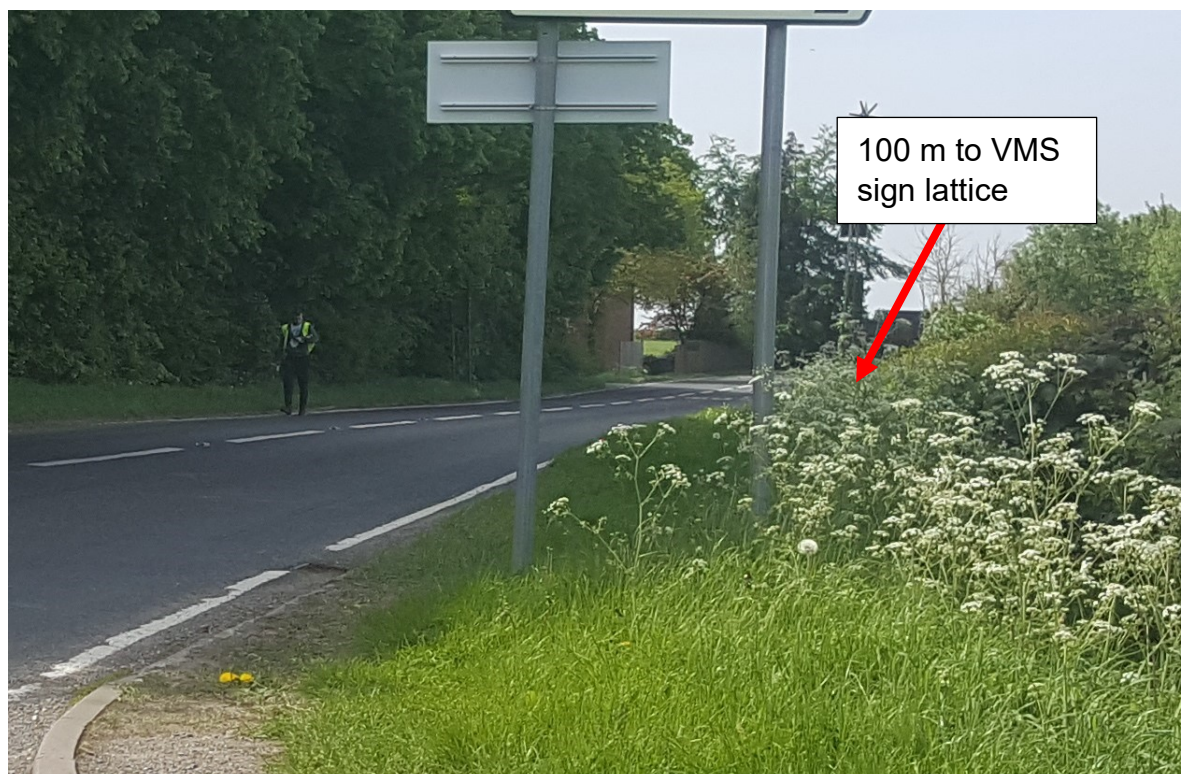
An X distance of 2.4m, is the final relaxation for 'exceptionally difficult circumstances'. This is only partially achieved as shown in Figure 15 and Figure 16 and even with the verges maintained, 160m visibility to the right is unlikely to be achieved. Recall that the required visibility point 210m to the right, for the design speed is around the bend to the south.

Figure 15 - looking left from Stockton Road at 2.4m x distance

Figure 16 – looking right from Stockton Road at 2.4m x distance

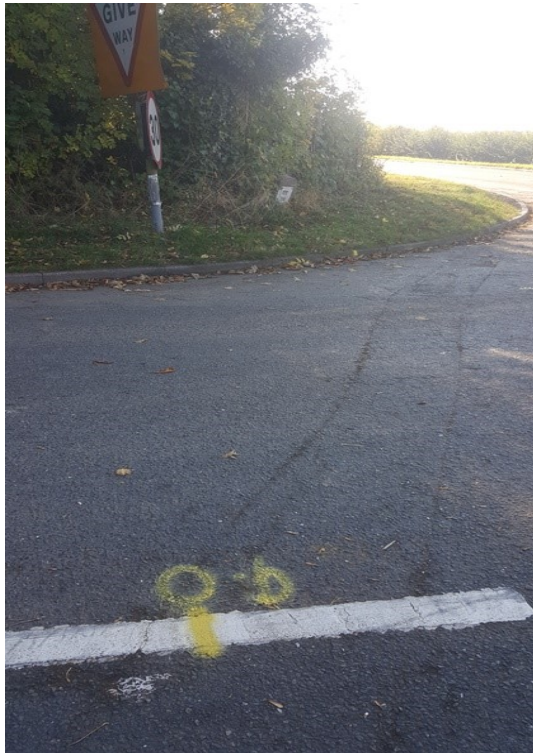
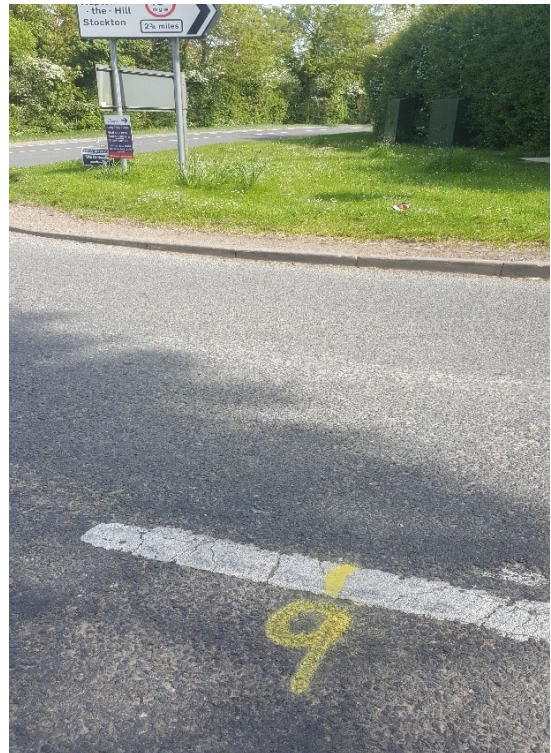
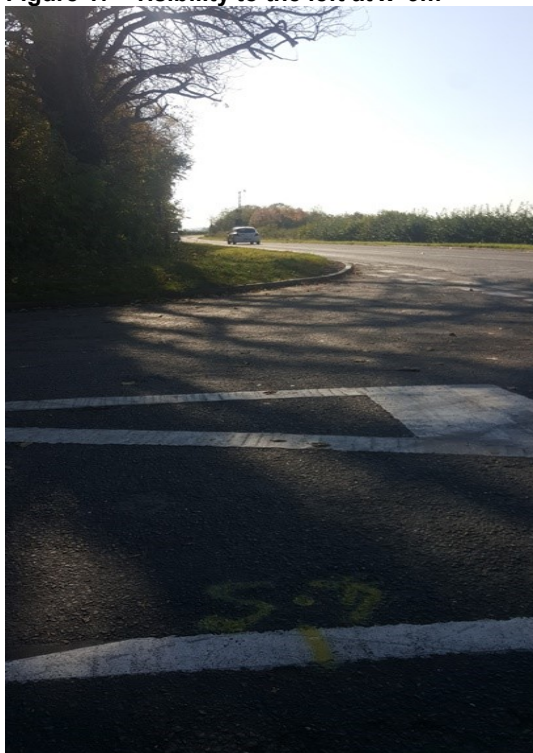
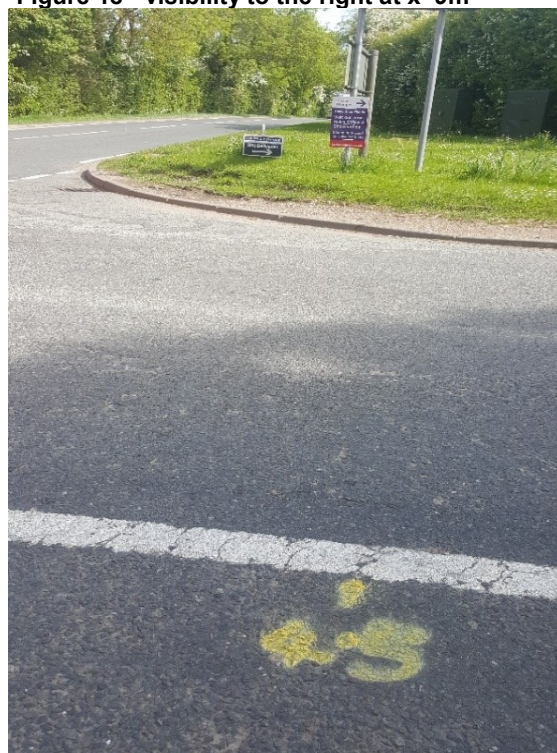
Figure 17 - visibility to the left at x=9m

Figure 18 - visibility to the right at x=9m

Figure 19 - visibility to the left at x=4.5m

Figure 20 - visibility to the right at x=4.5m

At an X distance of 4.5m the visibility to the right is still substandard and exacerbated by advertising boards for new houses. Such multi-coloured boards in the driver's eye line can make approaching motorcyclists very difficult to notice. Visibility to the left is acceptable at 4.5, 'X' distance.

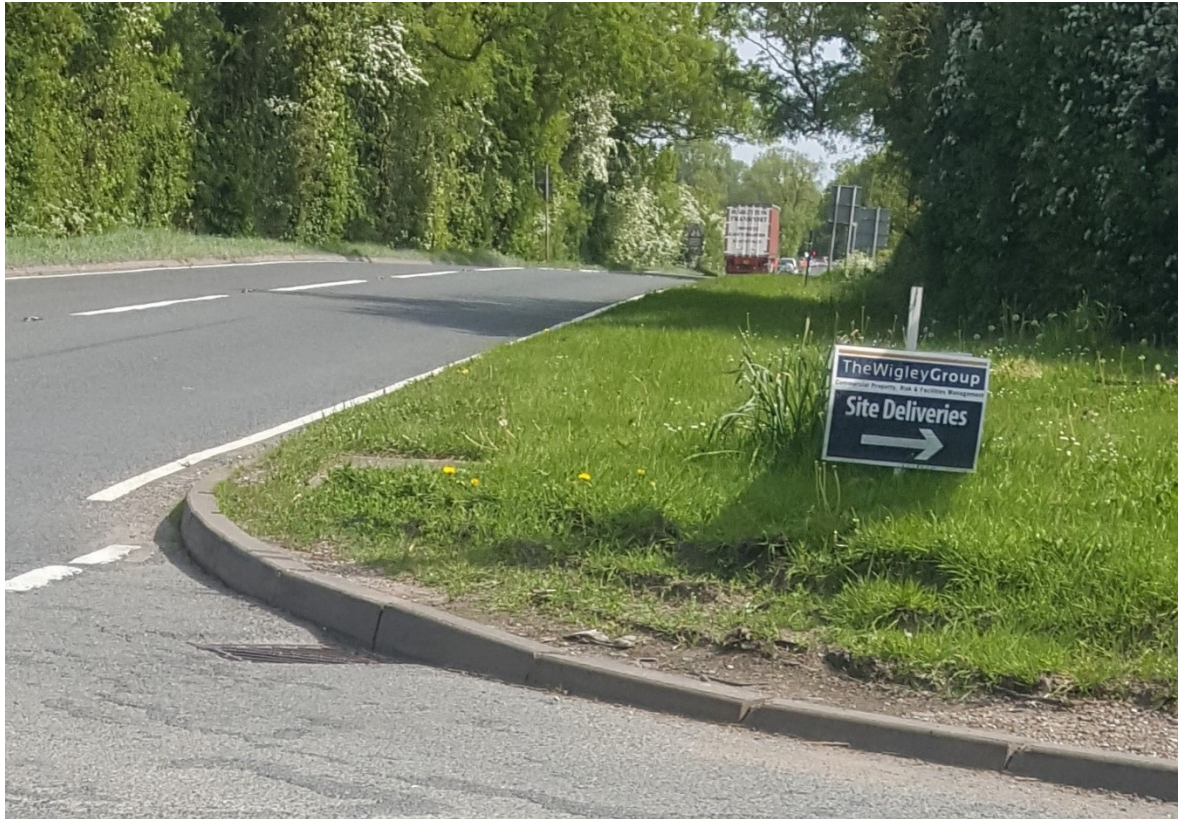
Even at an X distance of 2.4m the required visibility distance of 210m to the right is still compromised by the undulating vertical alignment.

Figure 21 - visibility to the right from Napton Road at x distance of 2.4m

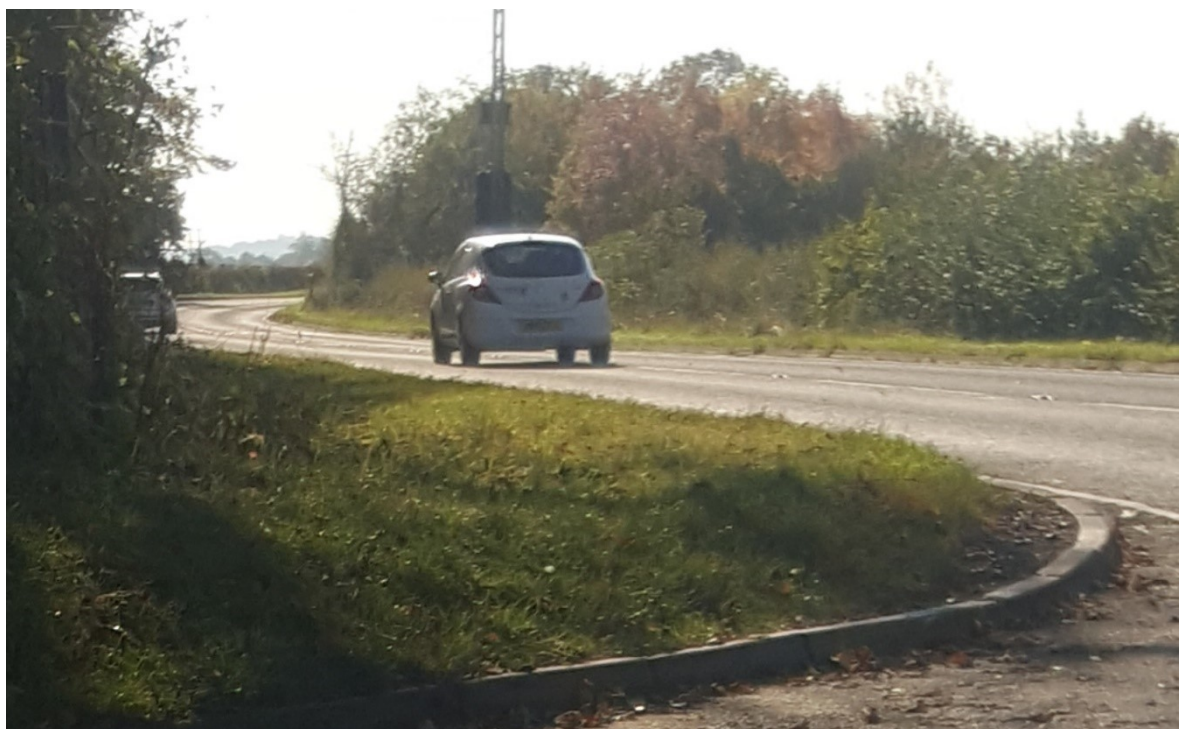
Figure 22 - visibility to the left from Napton Road at x distance of 4.5m

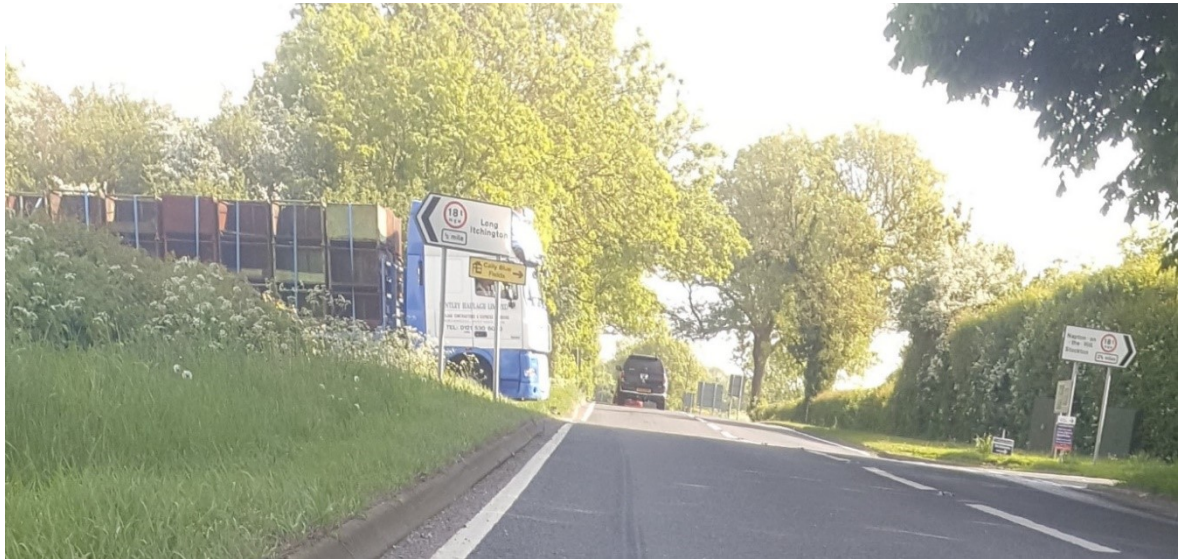
Figure 23 - new housing development sign blocks view from HGV cab

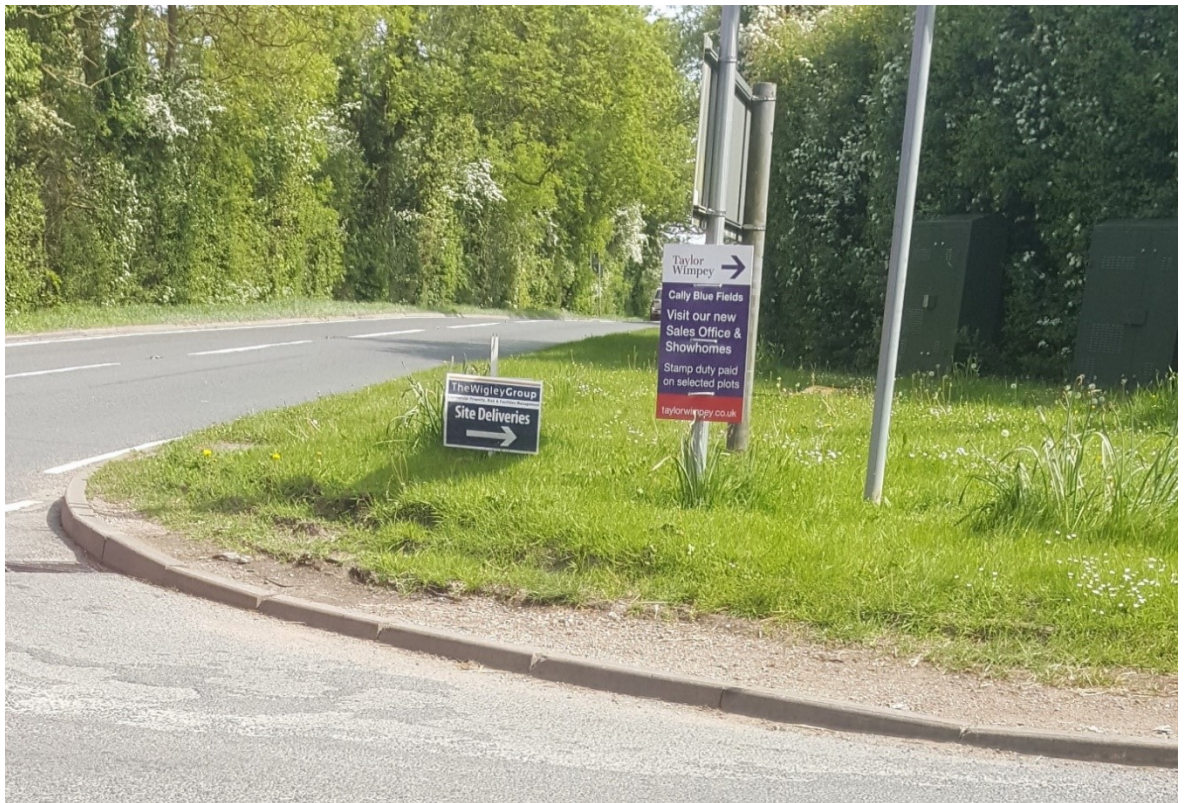
Figure 24 - new homes sign partially obstruct view at critical point

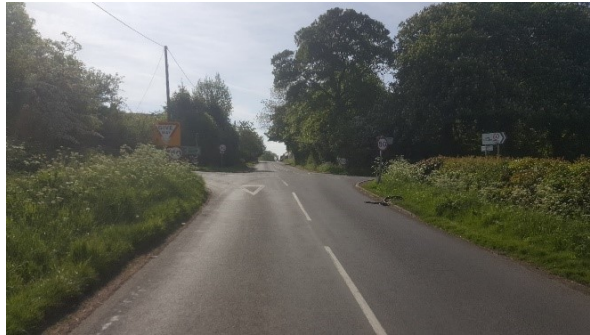
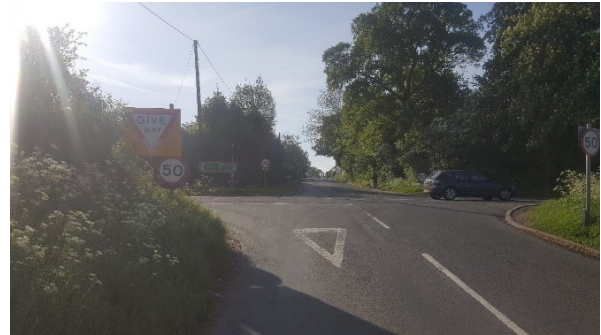
Approaching from Long Itchington on Stockton Road, the lie of the land and the channelling effect of the trees and bushes masks the junction with the A426 and makes the road appear to just continue uninterrupted into Stockton village. The white centre lines practically line up to emphasise this illusion. This appearance can confuse

unfamiliar drivers and result in them not realising there is a junction and driving straight across, as has been observed by a local resident and a braking skid mark observed on site suggests a driver noticed the junction at the last moment despite the advanced warning signs of a 'Give Way' ahead. This is exacerbated by the single nearside Give Way sign having deteriorated and being partly obscured by foliage and the painted Give Way triangle marking being partially eroded.

**Figure 25 - looking at junction from Stockton Road start of approach**

**Figure 26 - looking at junction from Stockton Road final approach**

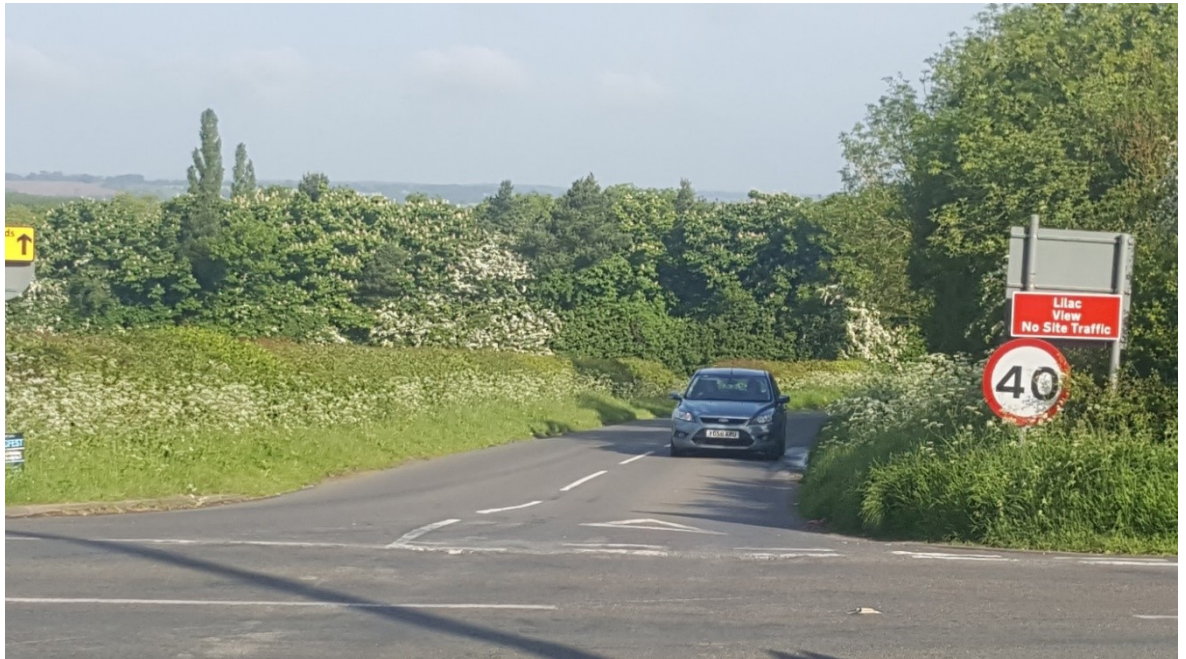
The approach from Long Itchington is steeply inclined for the last few metres and drivers rev their engines to overcome the gradient to avoid stalling. Some vehicles were observed spinning their wheels when turning right and the photographic evidence shows several wheelspin tracks from vehicles emerging on the gradient. The difficulty with the gradient is supported by observation of collision detritus (broken light lens glass) suggesting shunts and vehicles rolling backwards into a vehicle behind.

Figure 27 – Stockton Road approach from Long Itchington rises abruptly to meet the A426

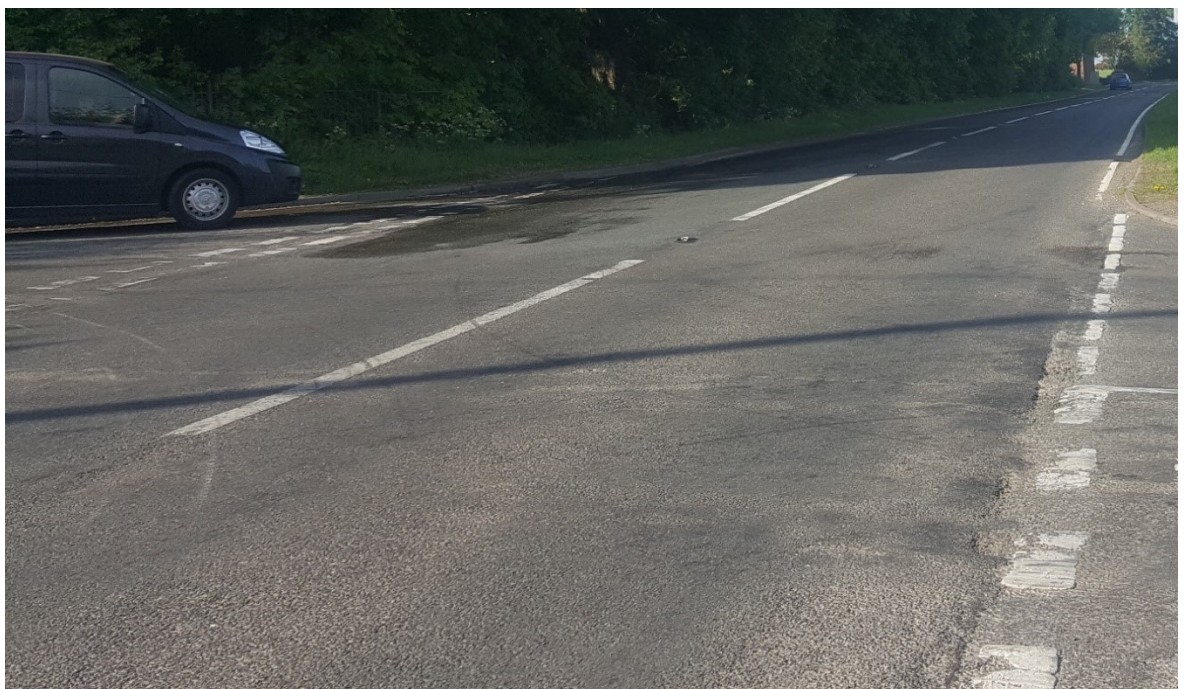
Figure 28 - evidence of aggressive right turning

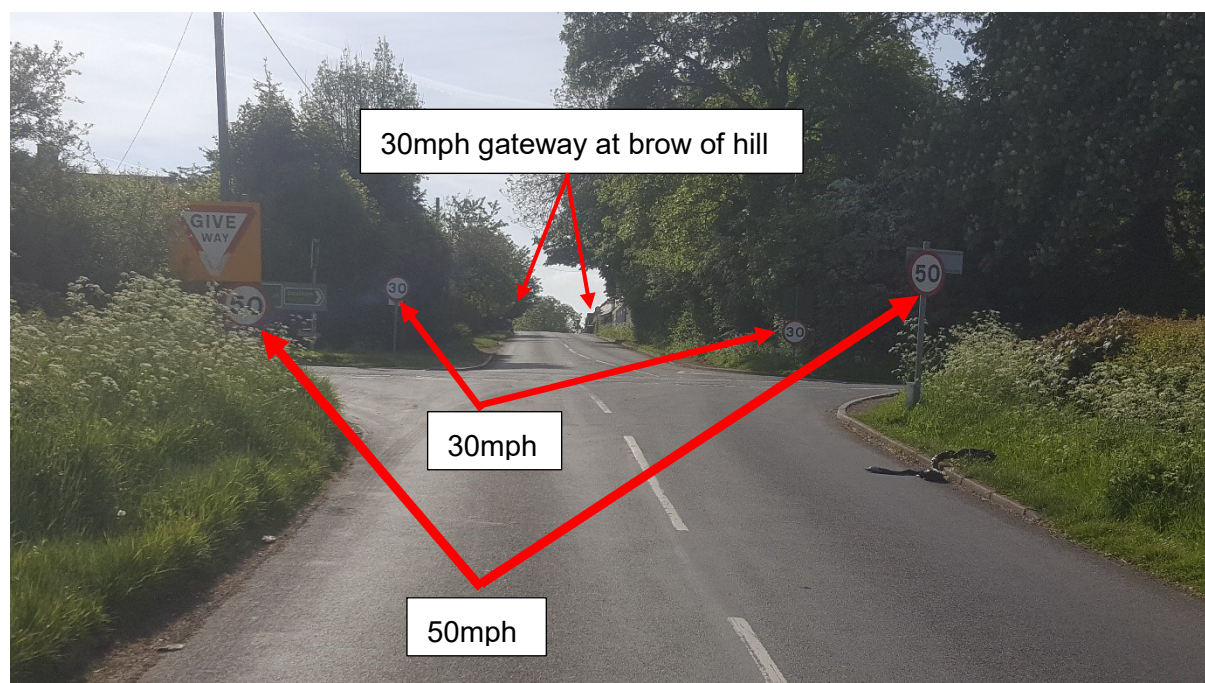
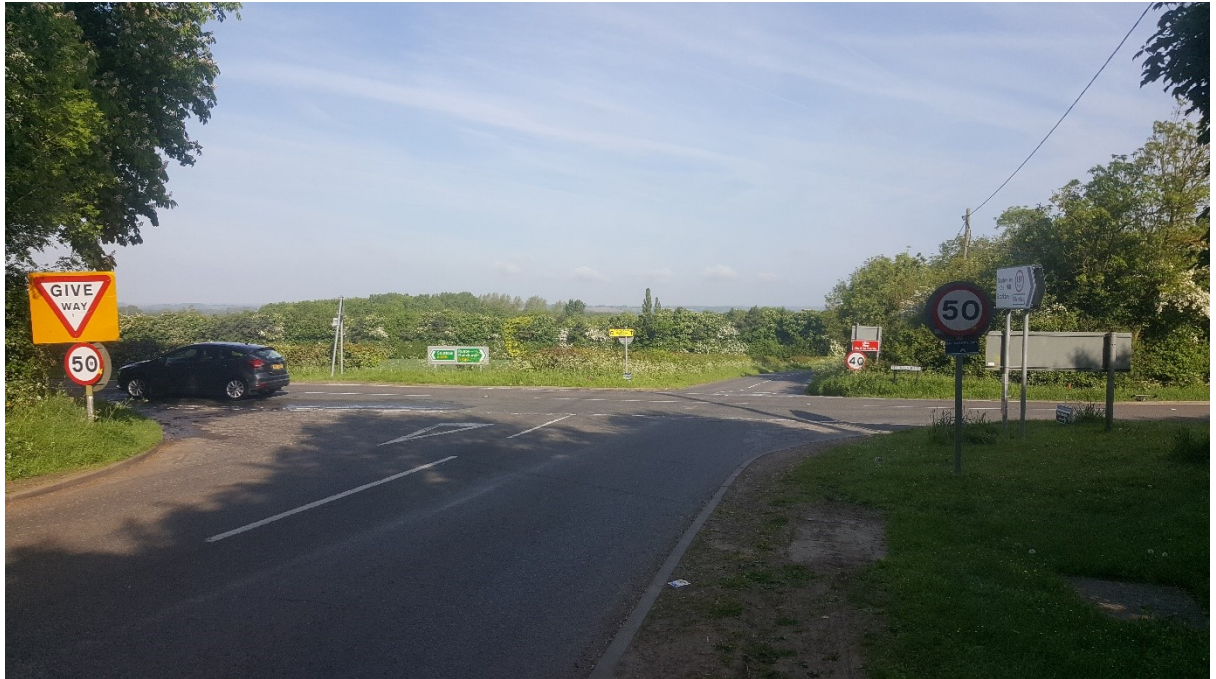
**Figure 29 – view from Stockton Road, confusing speed limit signing detracts from give way sign**

It also creates a degree of information overload with the plethora of signs which thereby distract from the most important one - the Give Way sign, which should not be co-located with a speed limit sign as shown in Figure 29 and Figure 30.

**Figure 30 – view from Napton Road, confusing speed limit signing detracts from give way sign**

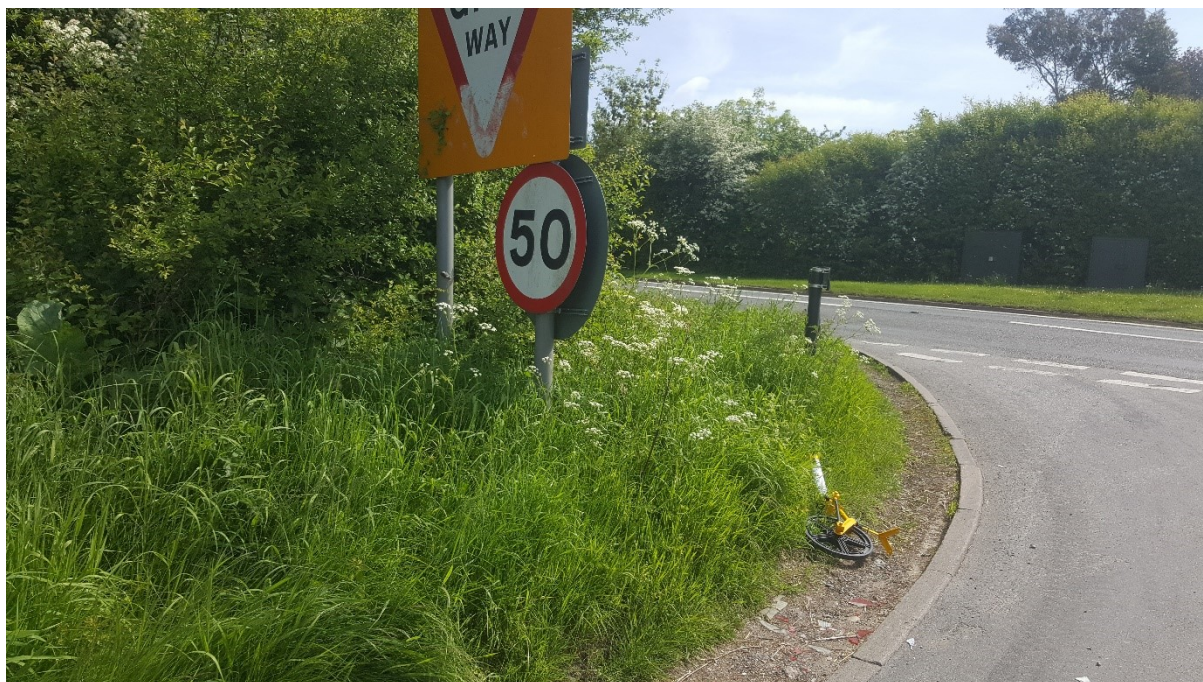
The Traffic Signs Manual, Chapter 3, states under the subheading SIGN MOUNTING, para 14.60: “Research has shown that the greater the number of signs that drivers are presented with simultaneously, the greater the difficulty they are likely to have in assimilating all the information. The problem of dealing with information overload increases with age, so that older drivers suffer disproportionately. **Terminal speed limit signs should not therefore normally be co-located with other signs**”.

**Figure 31 - speed limit sign should not be co-located with give way sign**

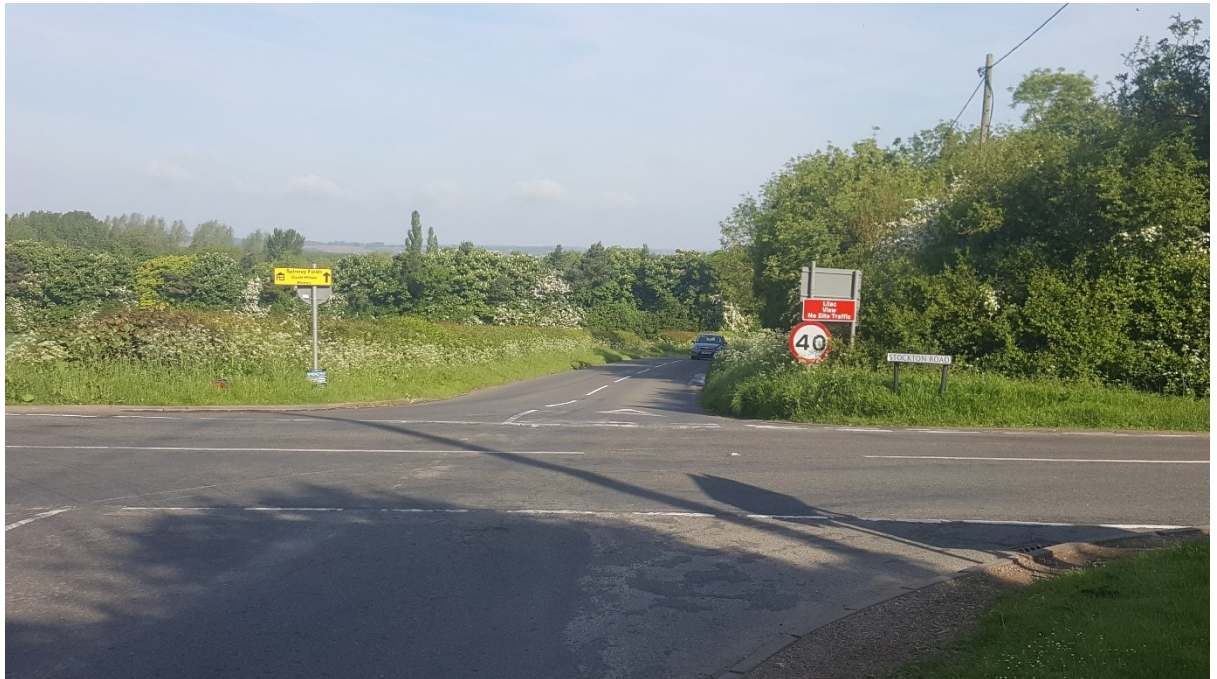
Figure 33 - 40mph sign on wrong side of Stockton Road and partly hidden

The 40mph sign at the start of Stockton Road must be relocated to the nearside post to be fully visible and enforceable.

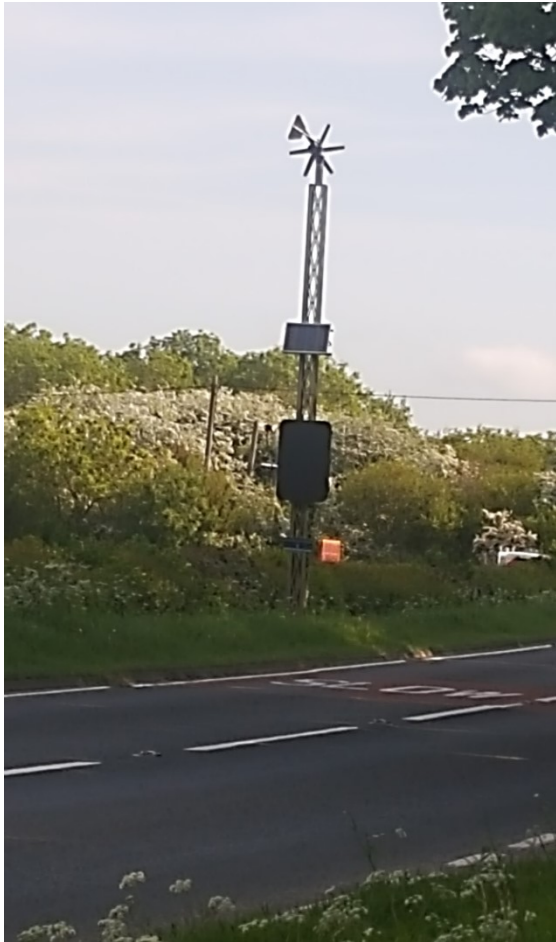
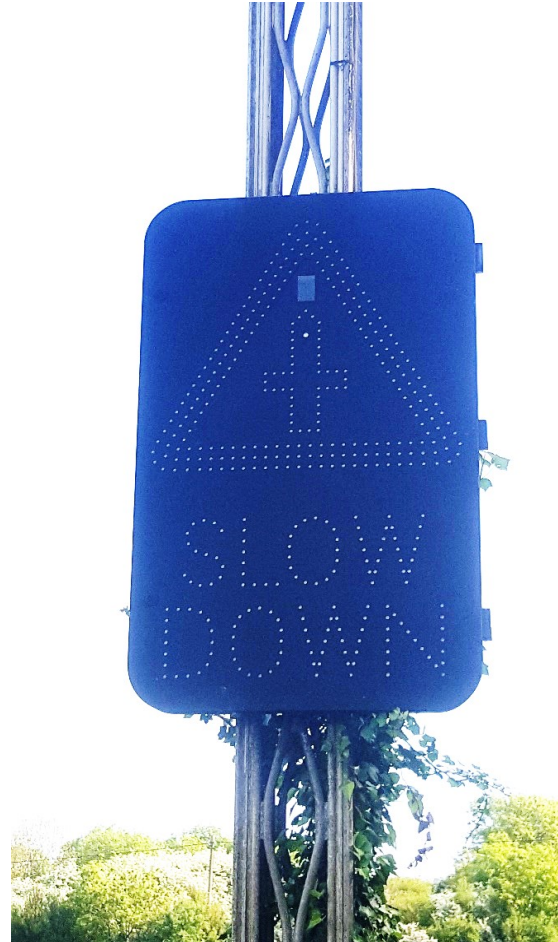
The Westcotec sign, (serial number TWJ1870), was installed by WCC. It is solar and wind powered, however the location of the installation is shaded from wind by the adjacent mature trees and the solar panel is too small to generate sufficient power from the available sunlight. This would explain the power failure. It is likely that the battery is now unusable.

Figure 34 - VAS in shade and shelter from trees

Figure 35 - VAS would be effective if it worked

A replacement sign is likely to be required and should be mains powered. The amount of power consumed is almost negligible. A full inspection by Westcotec would determine if anything is reusable.

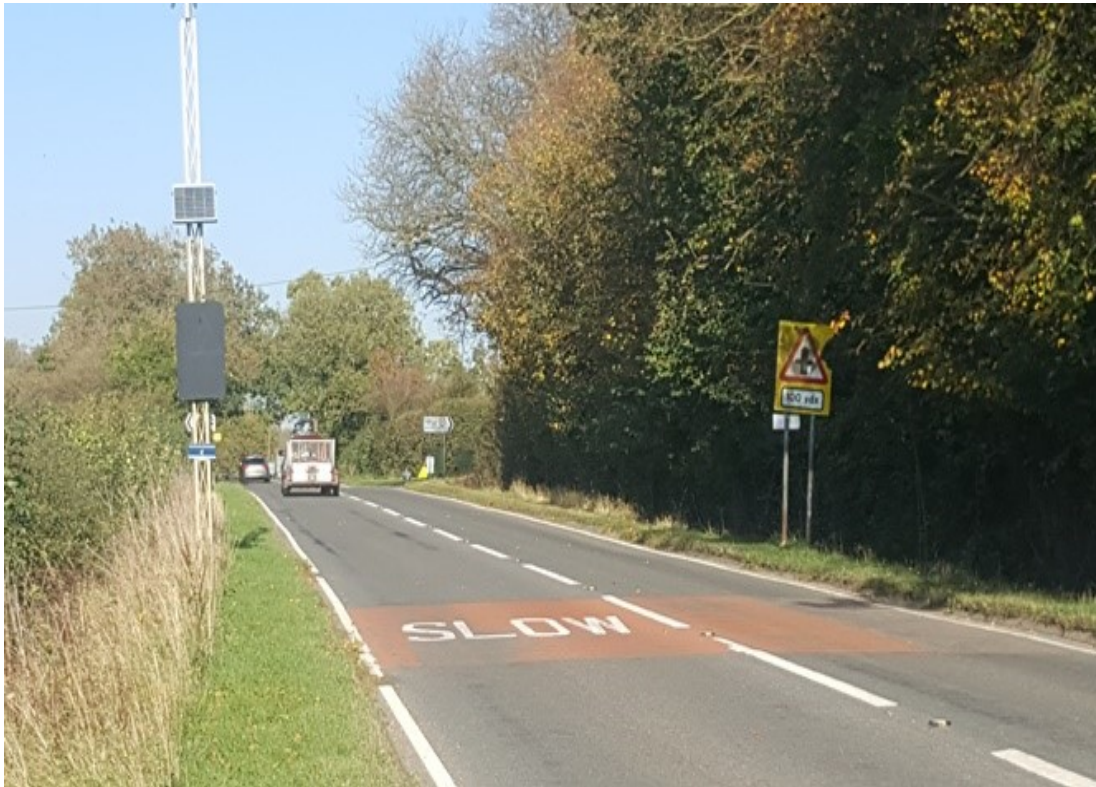
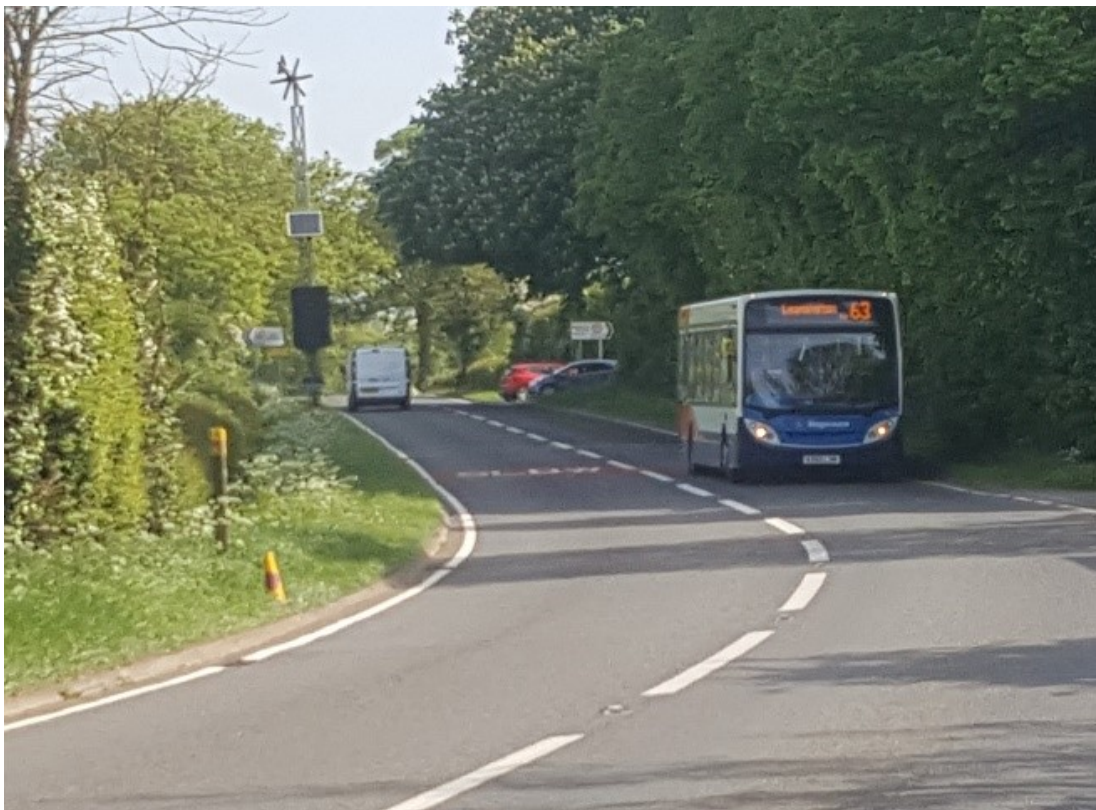
A fixed warning sign only on the offside, which could be masked by on-coming vehicles, does not meet the requirement. Warning signs should normally be placed on the nearside (or both sides as a pair). Currently there is no warning on the nearside and even if the VAS were repaired and reliable, only vehicles travelling at or above the trigger speed would receive the warning if the offside fixed sign is masked by oncoming large vehicles.

Figure 36 – cross-roads warning sign on offside

Figure 37 - offside cross-roads warning sign masked by bus

In order to improve the advance warning, a fixed crossroads warning sign could be added to the lattice post that supports the VAS. This would ensure that all motorists receive the warning.
